Debris/Ice/TPS Assessment and Integrated Photographic Analysis of Shuttle Mission STS-68

**DEBRIS/ICE/TPS ASSESSMENT
AND
INTEGRATED PHOTOGRAPHIC ANALYSIS
OF
SHUTTLE MISSION STS-68**

30 September 1994

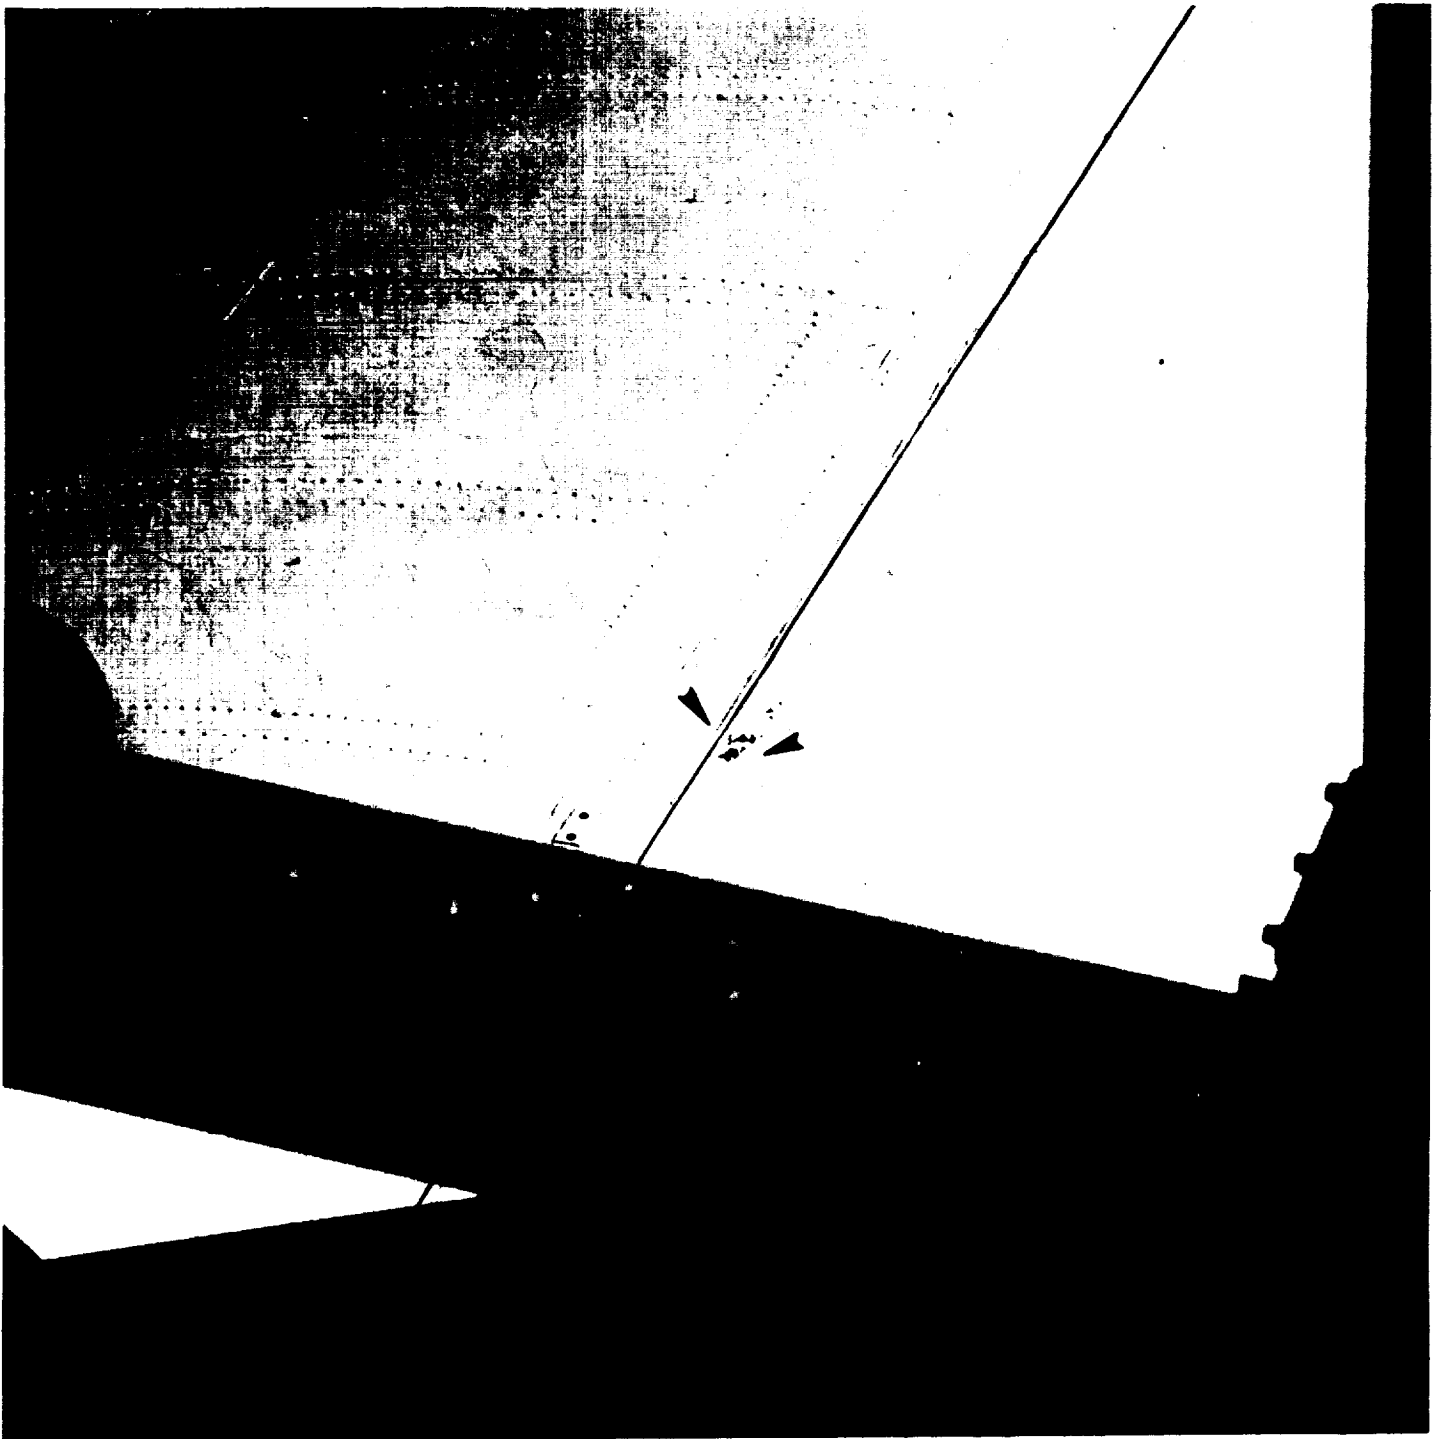
Photo 39 : Tear/Scuff Mark on Payload Bay Door FRSI

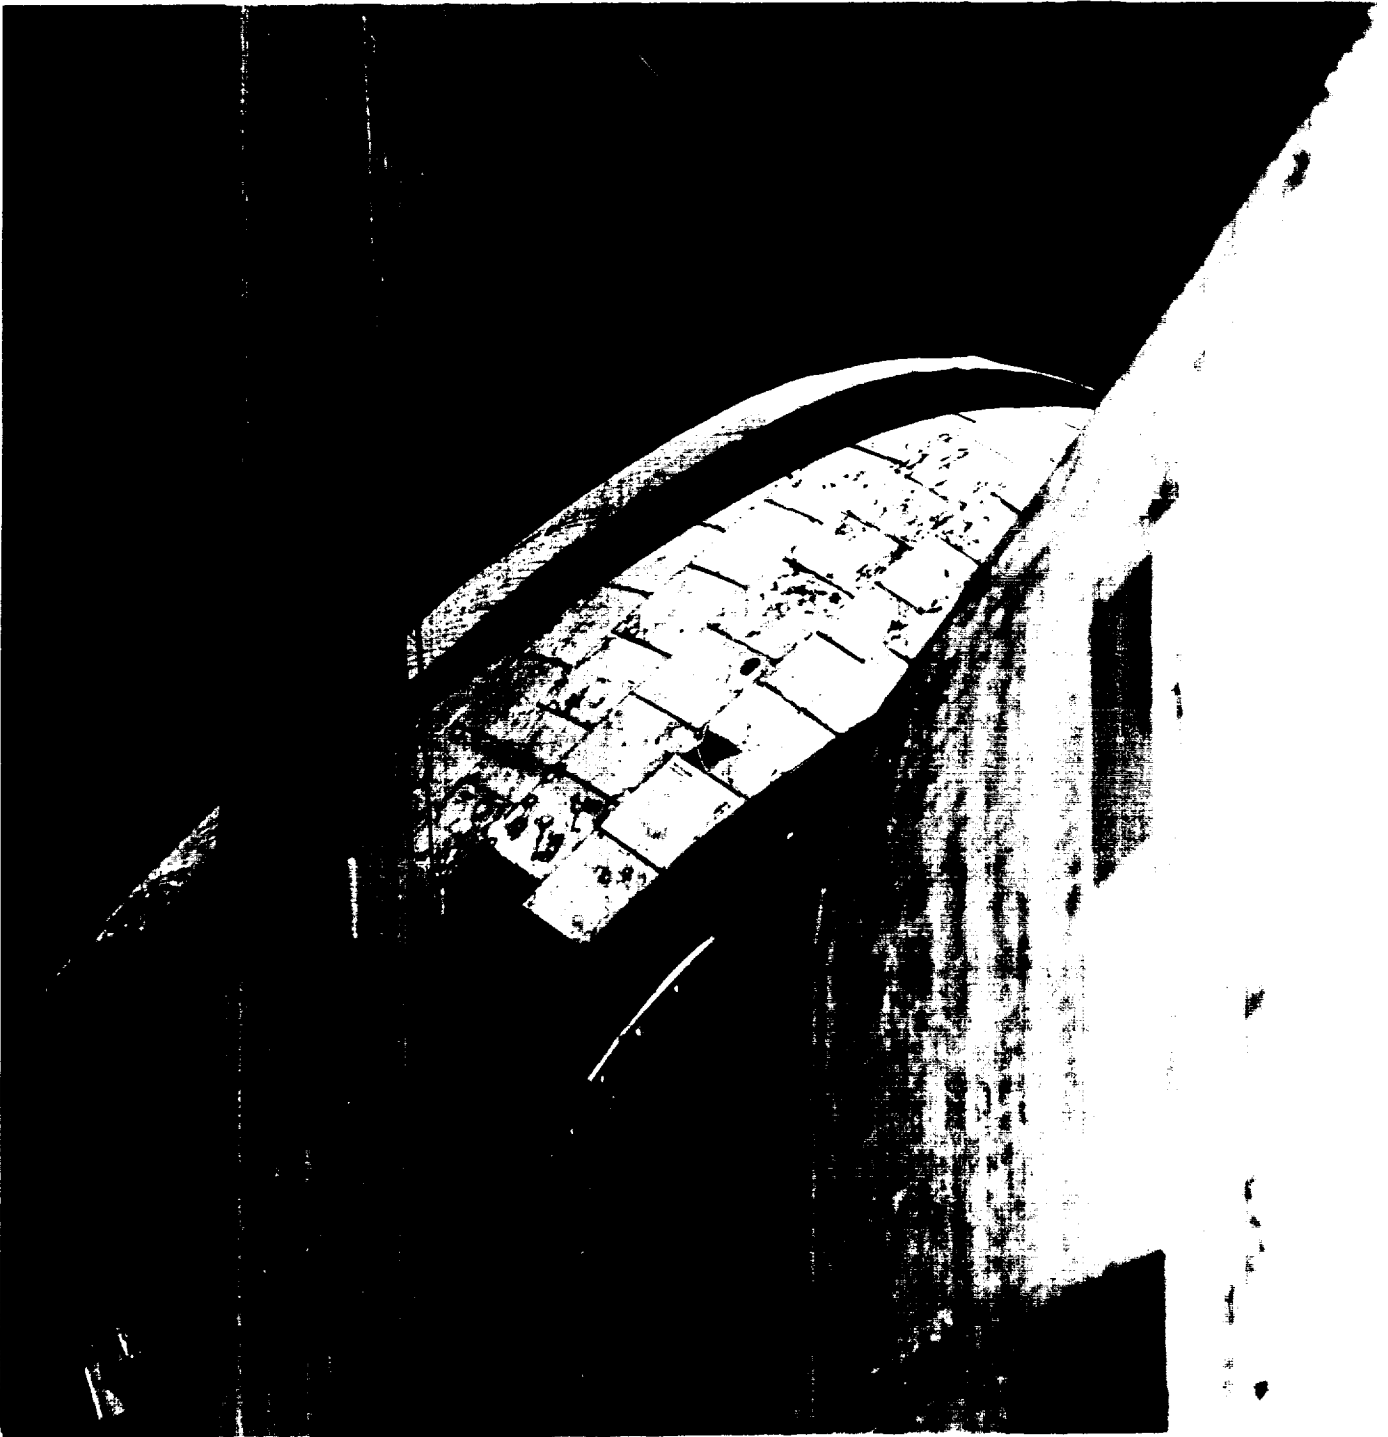
The largest tile damage site on the Orbiter was located on the RH OMS pod forward facing surface and measured 5 inches by 5 inches by 2 inches. This damage site had not been significantly changed by re-entry aerodynamics/heating from the condition observed in the on-orbit video review. The missing window #8 perimeter tile V070-390068-059 piece, reported by the flight crew two days into the flight, most likely caused this damage. The edge of the tile fragment is believed to be the source of three small tears/scuff marks on the payload bay doors in a line between the original tile location and the damage site on the RH OMS pod. In addition, post flight analysis of samples from the OMS pod damage site revealed the presence of black RCG tile coating material. An improper repair to the carrier panel hole with subsequent contamination of the SIP/bondline is the leading candidate for the loss of the tile (IFA STS-68-V-01).

Photo 40 : Impact Damage Site on RH OMS Pod

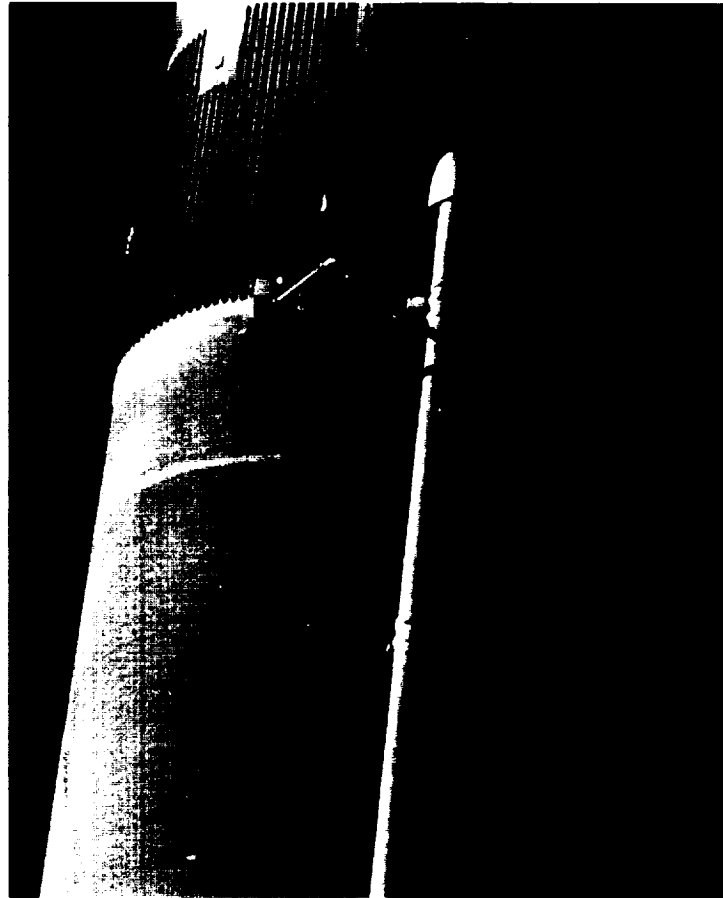
Figure 2.4.2.1 Light Colored Mark on Intertank Stringer Head (*STS068-300-060*).

- 1) A light colored mark, probably missing TPS, is visible on an intertank stringer head forward of the ET/Orbiter forward attach bipod. There is a dark area in the center of the light colored mark(Figure 2.4.2.1). This mark measured 12 by 5 inches in dimensions.
- 2) A light colored mark is visible on the aft edge of the cross beam just forward of the LO2 umbilical.
- 3) Minor TPS erosion and voids are visible on the aft LO2 feed line bellows and support bracket.
